CORWUM s.r.o. Projektovanie a diagnostika

| Stage: | STRUCTURAL AND CONSTRUCTION-TECHNICAL ASSESSM |
| Project name: | GRÖSSLING BATH |
| Date: | 02/2020 |

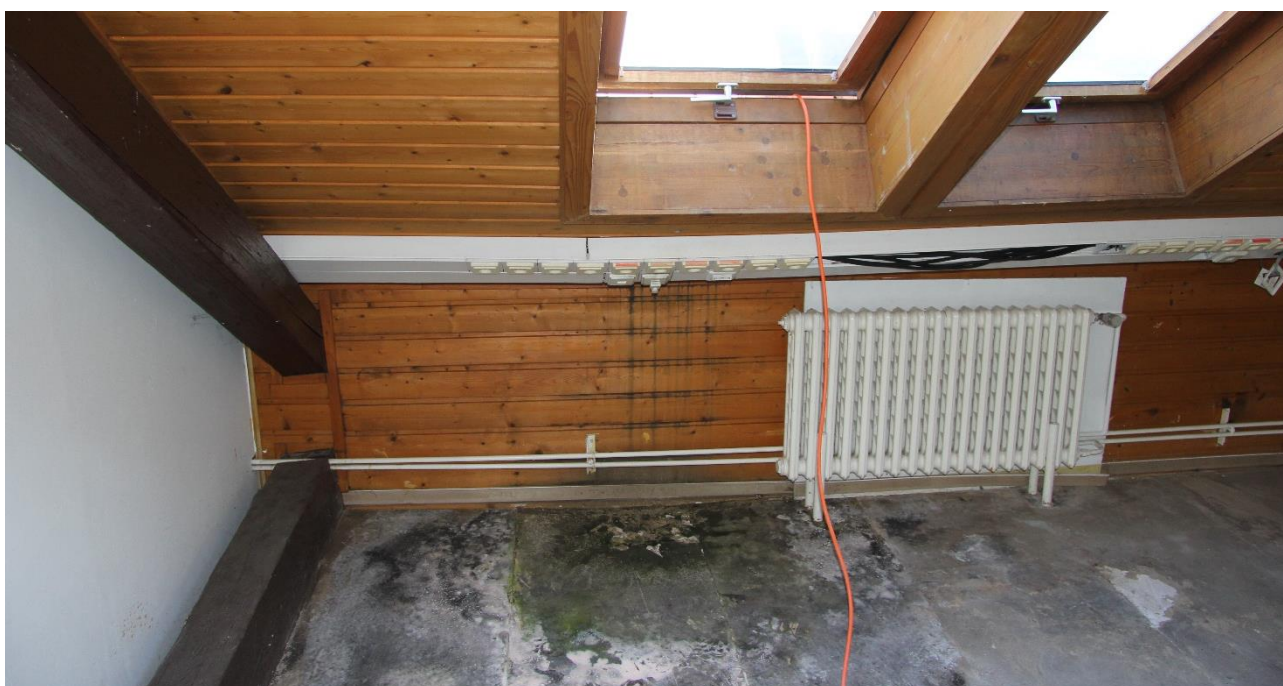
Inspection of the roof trussing discovered biotically damaged rafters at the place of the roof lights and chimneys [BX1], roofing is damaged, it is leaking at the given places. In addition to the rafters which are completely rotted out (and their deformation is also visible at the filler block), the eaves plate may also be damaged. This structurally unsound condition was discovered only in one place, but more or less damaged wooden elements are expected around the chimneys along the entire roof (this applies also to the part A). The exact condition will be discovered after the roof trussing is stripped down.

Fig.: 1 Leaking in the loft

Places of active leaks shall be repaired as soon as possible, even only temporarily. During the reconstruction, when the roof trussing is stripped down it is necessary to identify all damages and damaged rafters must be replaced with new ones, or a prosthesis must be applied, according to the extent of damage.

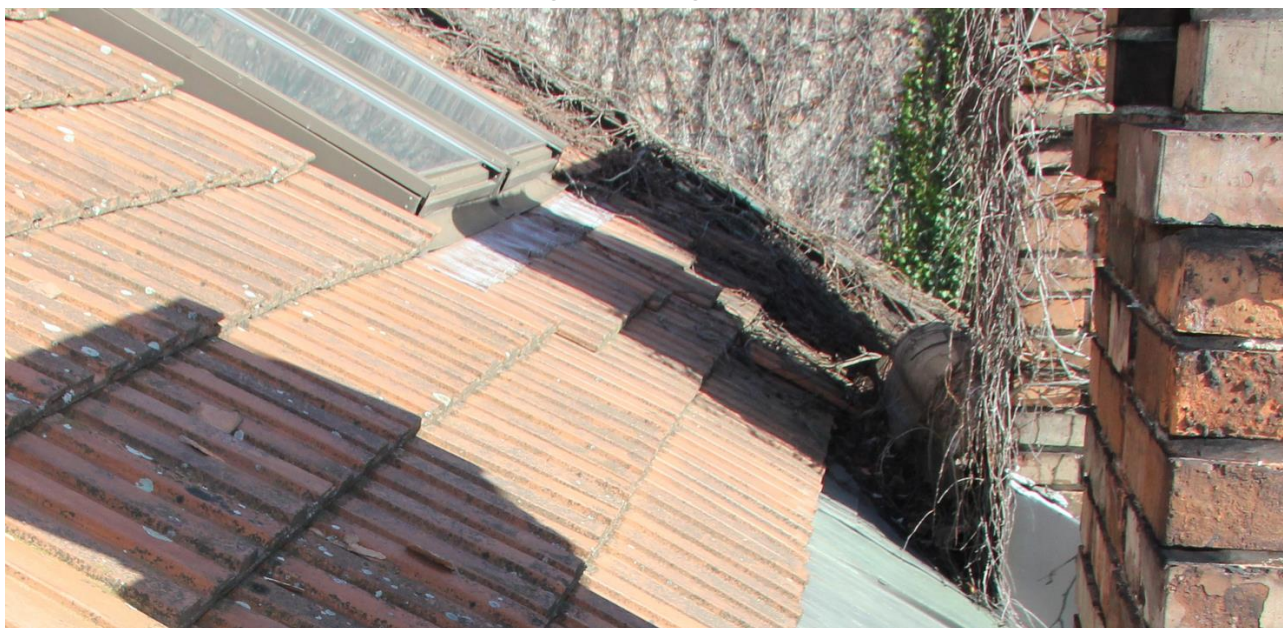
Fig.: 2 Critical detail – between the roof light and chimney

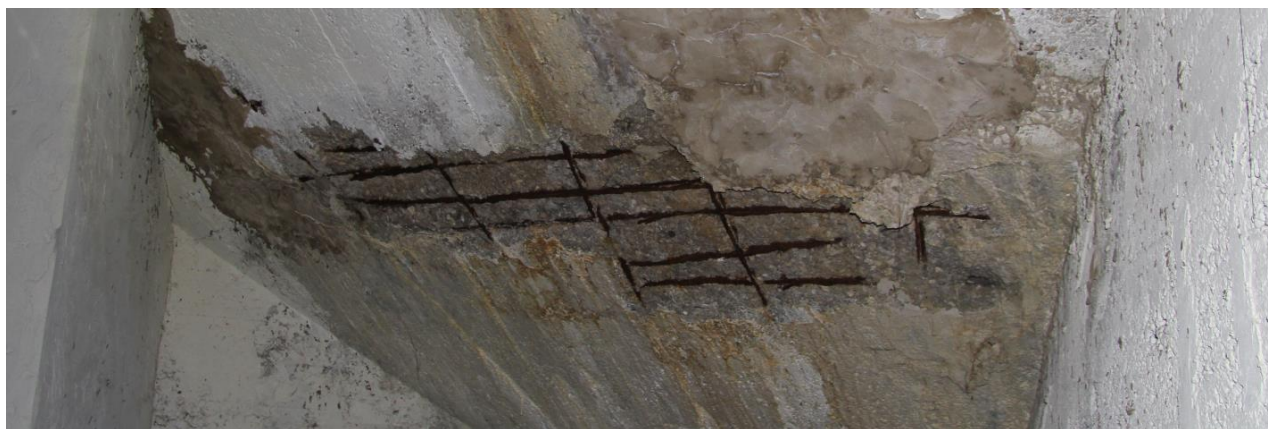
The ceiling slab above the basement has significantly corroded lower reinforcement, the cover layer is flaking and the mechanical bond of reinforcement and concrete is significantly disrupted [CX1]. It is caused by past damp operation and probably non-functioning water-proofing, or the concrete was unsuitable for such an environment and the reinforcement cover layer was thin. The damage affects almost the entire area.

Fig.: 3 Damaged cover layer and corroded reinforcement

In this case the best solution would be to completely remove the ceiling slab and to create a new ceiling structure – a copy of the original one.

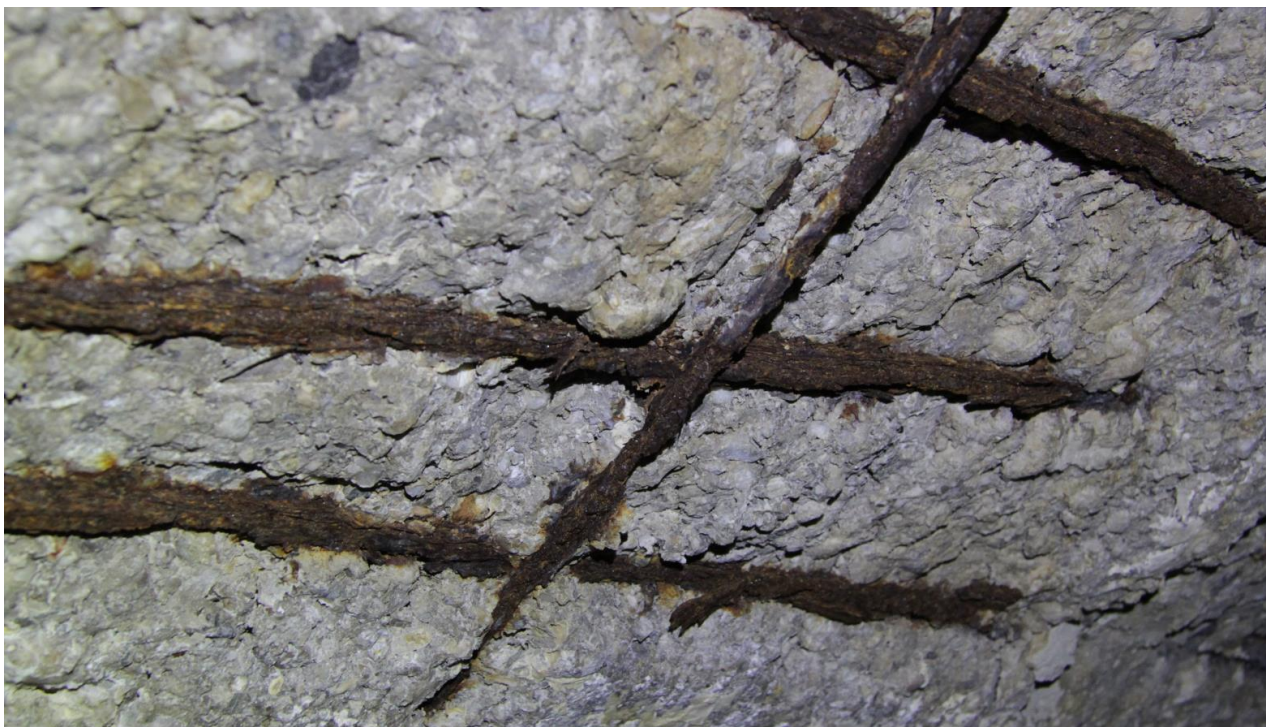
Fig.: 4 Damaged cover layer and detail of the corroded reinforcement

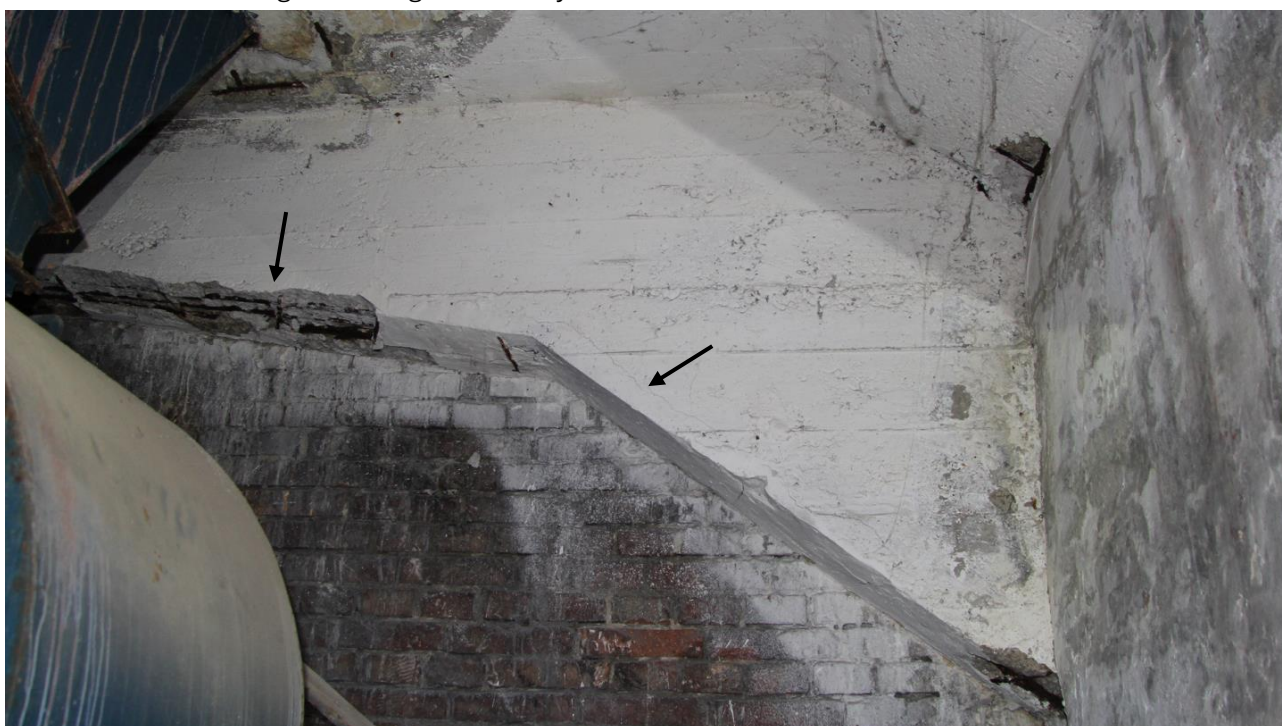
Fig.: 5 View of the ceiling rib – damaged lower reinforcement, cracked cover layer

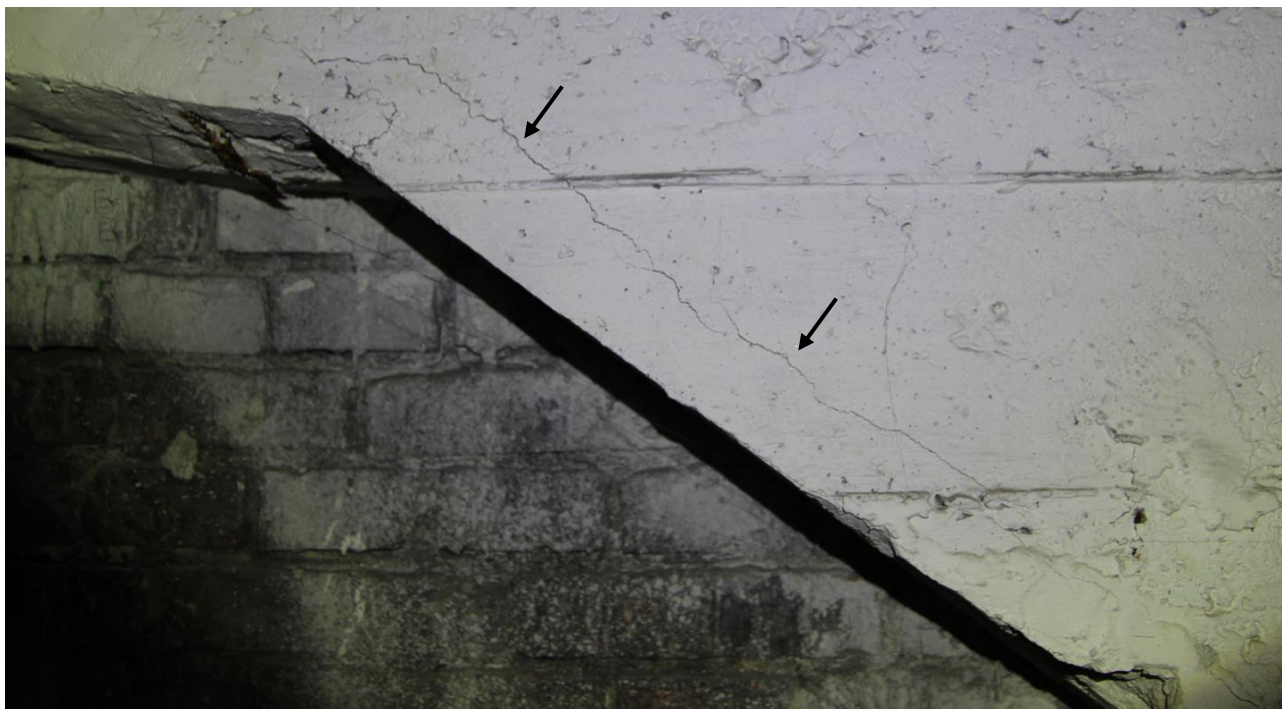
Fig.: 6 View of the ceiling rib – damaged lower reinforcement, cracked cover layer

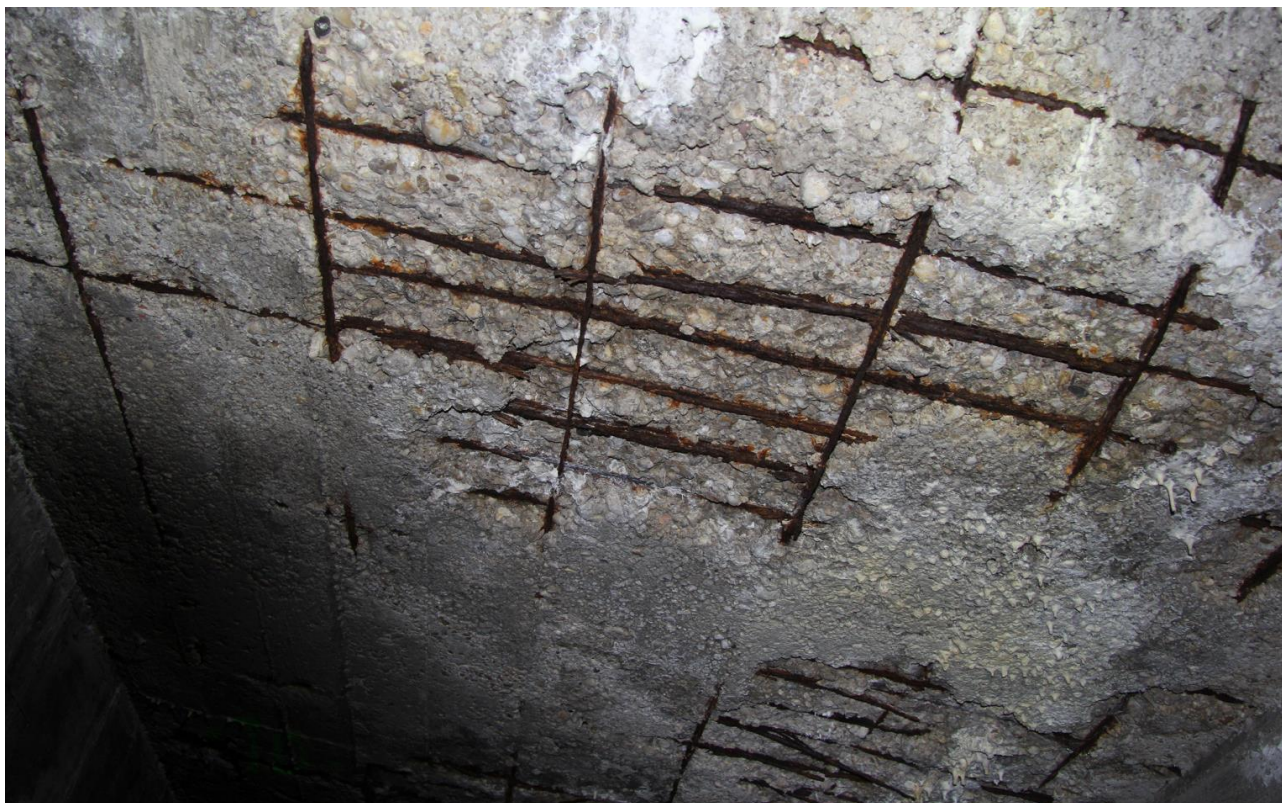
Fig.: 7 Damaged cover layer and detail of the corroded reinforcement

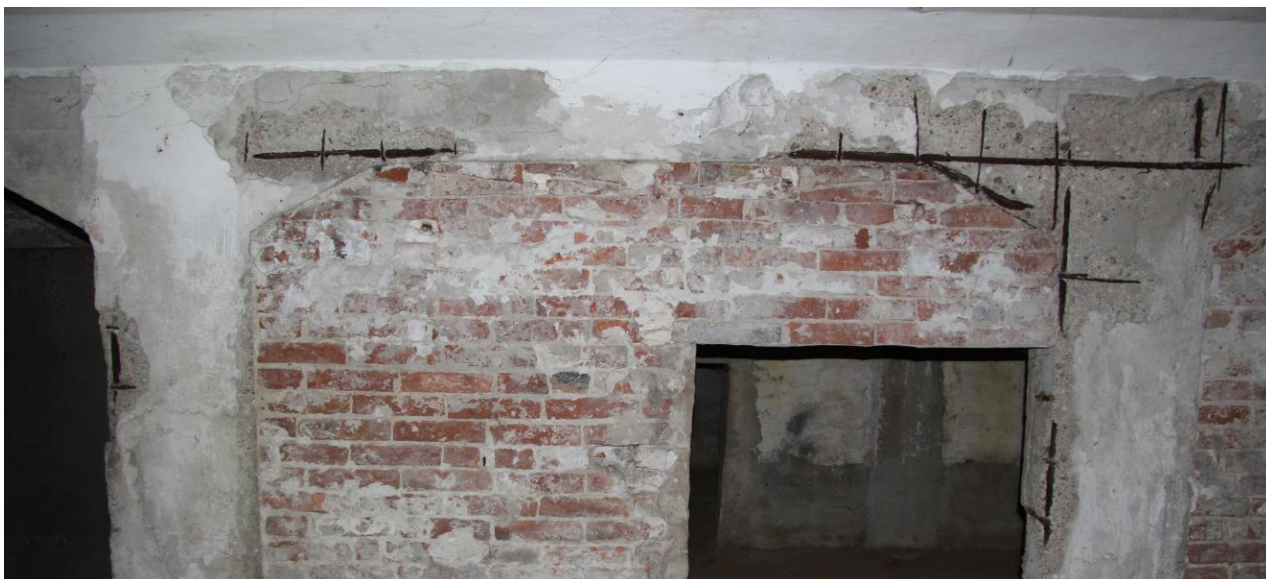
Reinforced concrete structures have insufficient cover from the basement and the reinforcement is corroded [EX1]; the mechanical bond of reinforcement and concrete is not globally disrupted, only locally. Reconstruction works were carried out in the past; the structure of the pool was covered with additional concrete which should ensure water-tightness and overall load-bearing capacity of the structures. However, the height of the additional concrete is not proportionate and the reinforced concrete slab does not ensure sufficient water-tightness.

Fig.: 8 Damaged cover layer – it can be re-profiled

We propose to remove the additional concrete layers of the pool and create a new, thinner slab on which the water-proofing layer shall be applied (it must be resolved with

the pool operator). If the water column in the pool significantly drops, the additional concrete may be preserved and an intermediate reinforced concrete ceiling shall be created. Insufficient cover layer of the reinforcement shall be restored with the use of suitable reconstruction mortars. The original reinforced concrete structures shall only be used as permanent formwork. The structures of walls and beams can be reinforced by underpinning, as was partially implemented in the past.

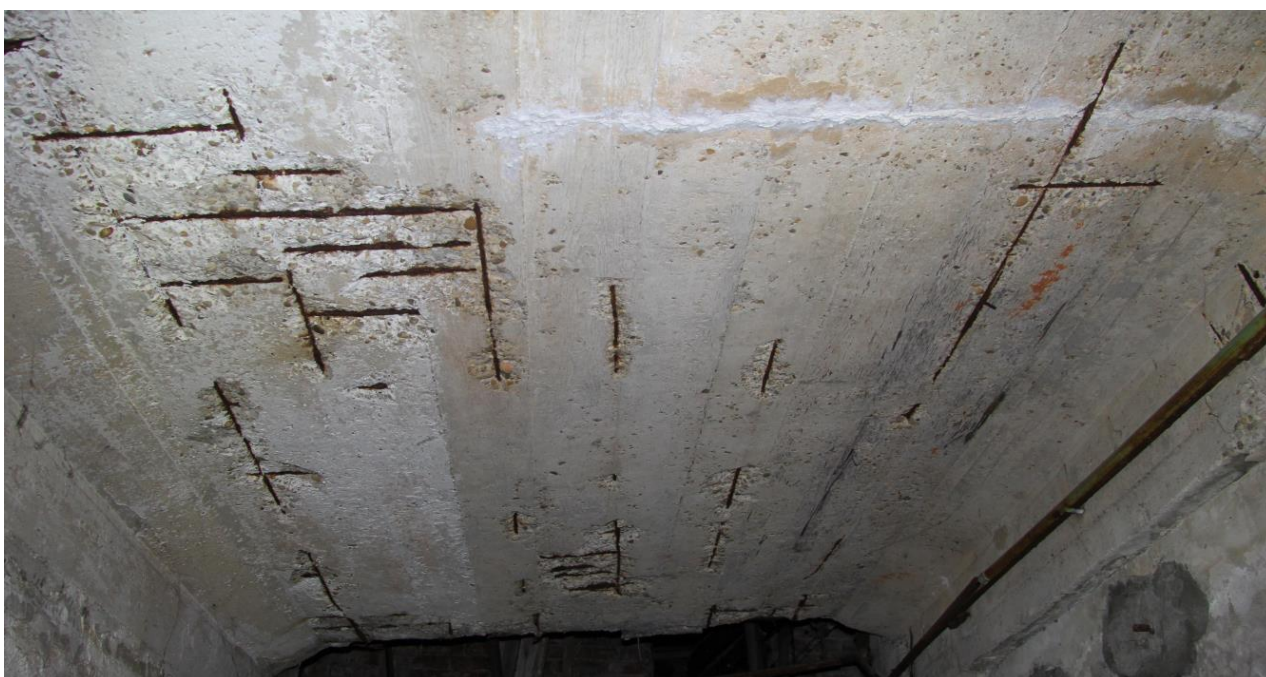
Fig.: 9 Damaged cover layer – it can be re-profiled

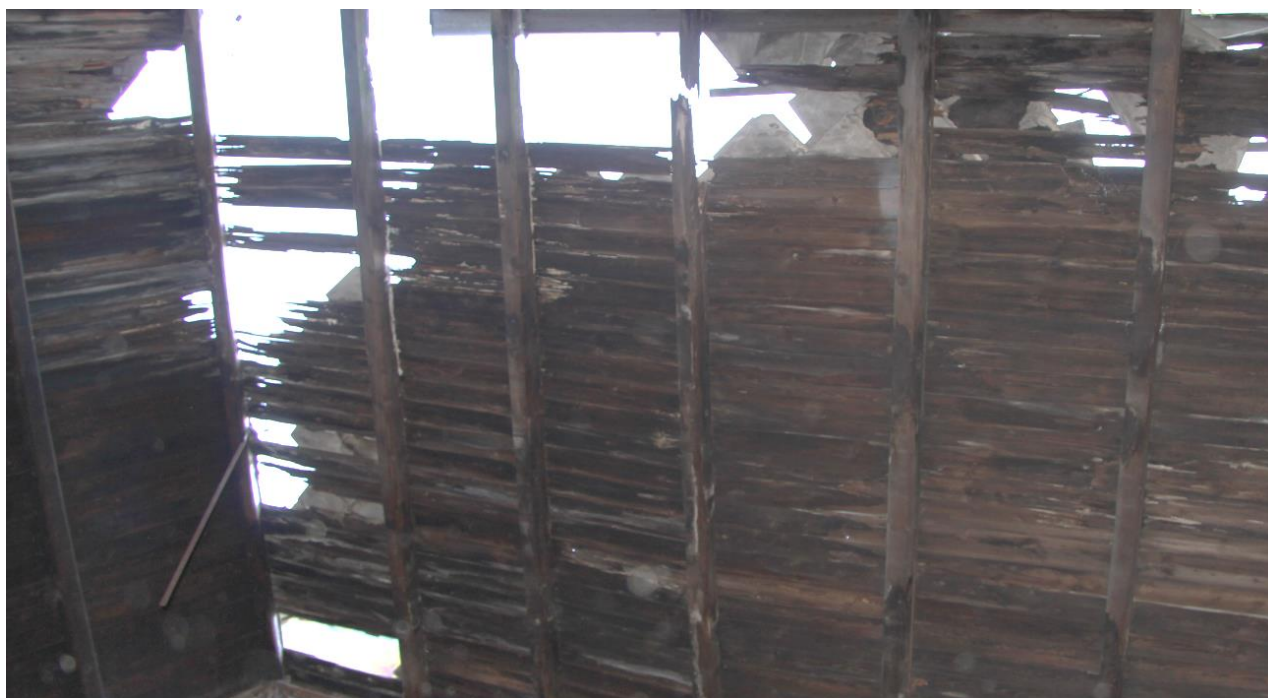
The roof of the boiler house is significantly damaged; many asbestos plates are missing [GX1]. Long-term leaking caused the damage of the Italian-system rafters by rot, secondarily by wood-destroying insects [GX2]; at present, many of the rafters are broken or their sections are significantly weakened. This situation is extremely structurally unsound and it is dangerous to move in these areas.

Fig.: 10 Damaged roof

It is proposed to completely remove and replace all wooden elements of the roof with new ones (formwork + Italian-style rafters). The original structure without damages caused by rot can withstand and safely transfer loads based on the factor of present fitness if the new load will not significantly differ from the original one (the new composition of the roof deck must be formed accordingly).

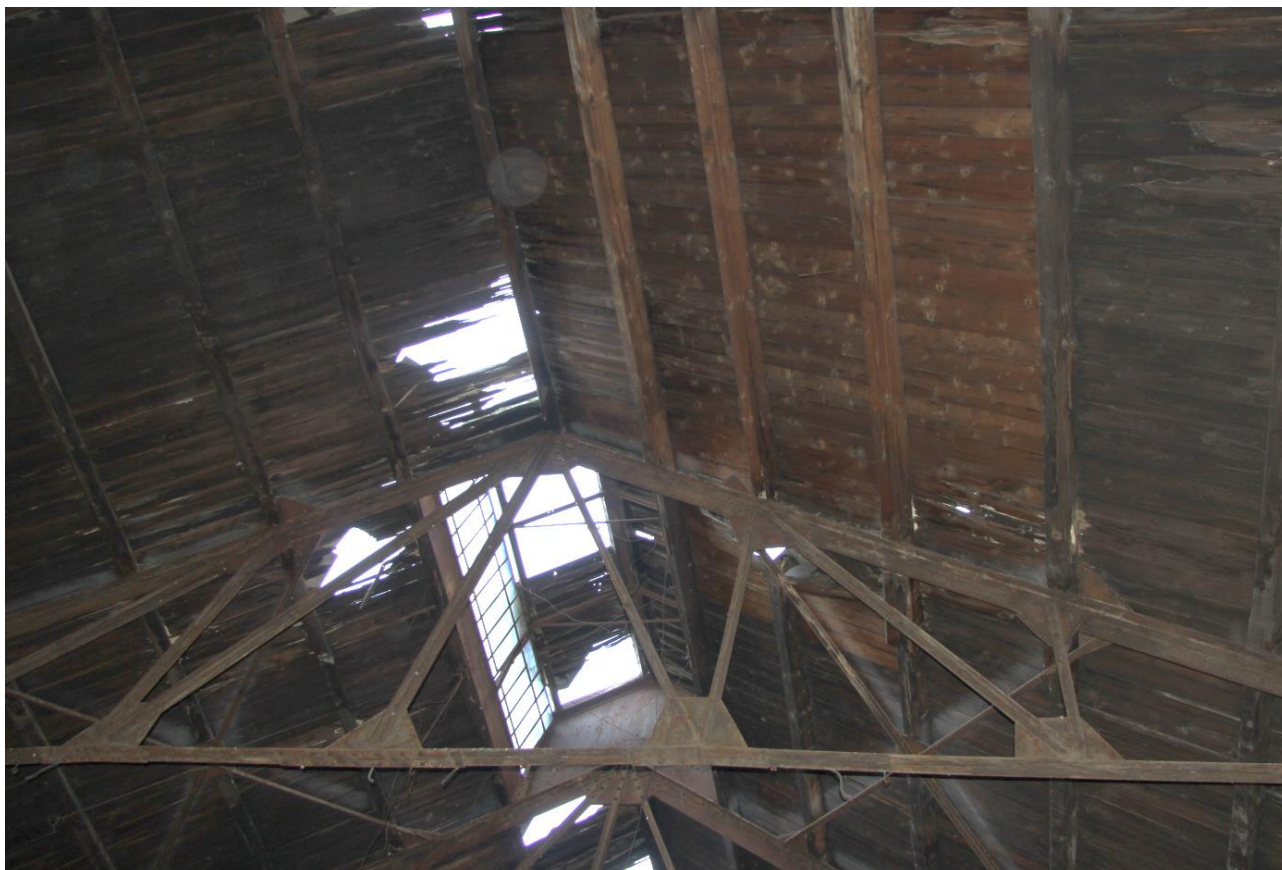
Fig.: 11 Damaged roof

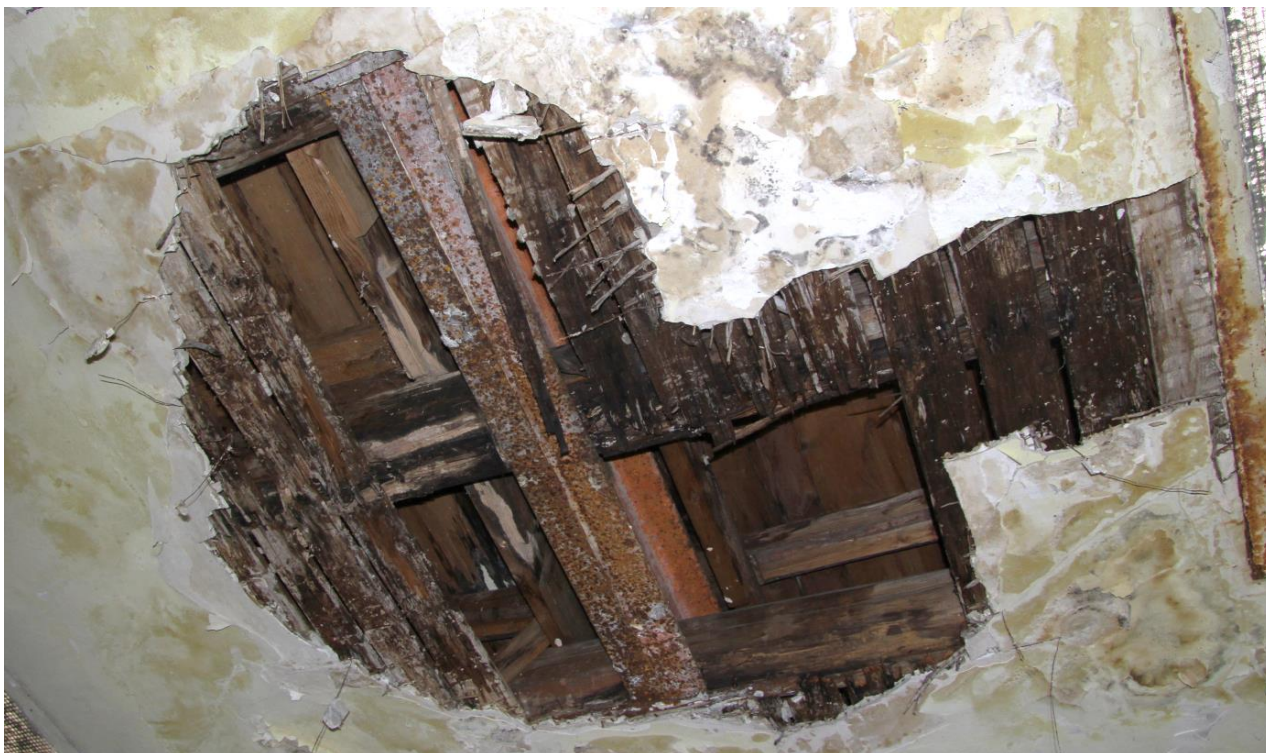
The roof above the part "K" is significantly damaged; the roof deck is not functional and is leaking in many places [KX1]. Long-term leaking has caused the damage of secondary wooden beams, mainly by rot [KX2].

Fig.: 12 Damaged roof

The roof structure shall be fully supported by wood supports; the roof deck shall be temporarily repaired with the use of asphalt patches. This repair is only temporary until the bath is completely reconstructed. Should this structure be preserved in the future, it is suggested to leave the composite steel-concrete columns which are in good condition, as well as the main steel girders.

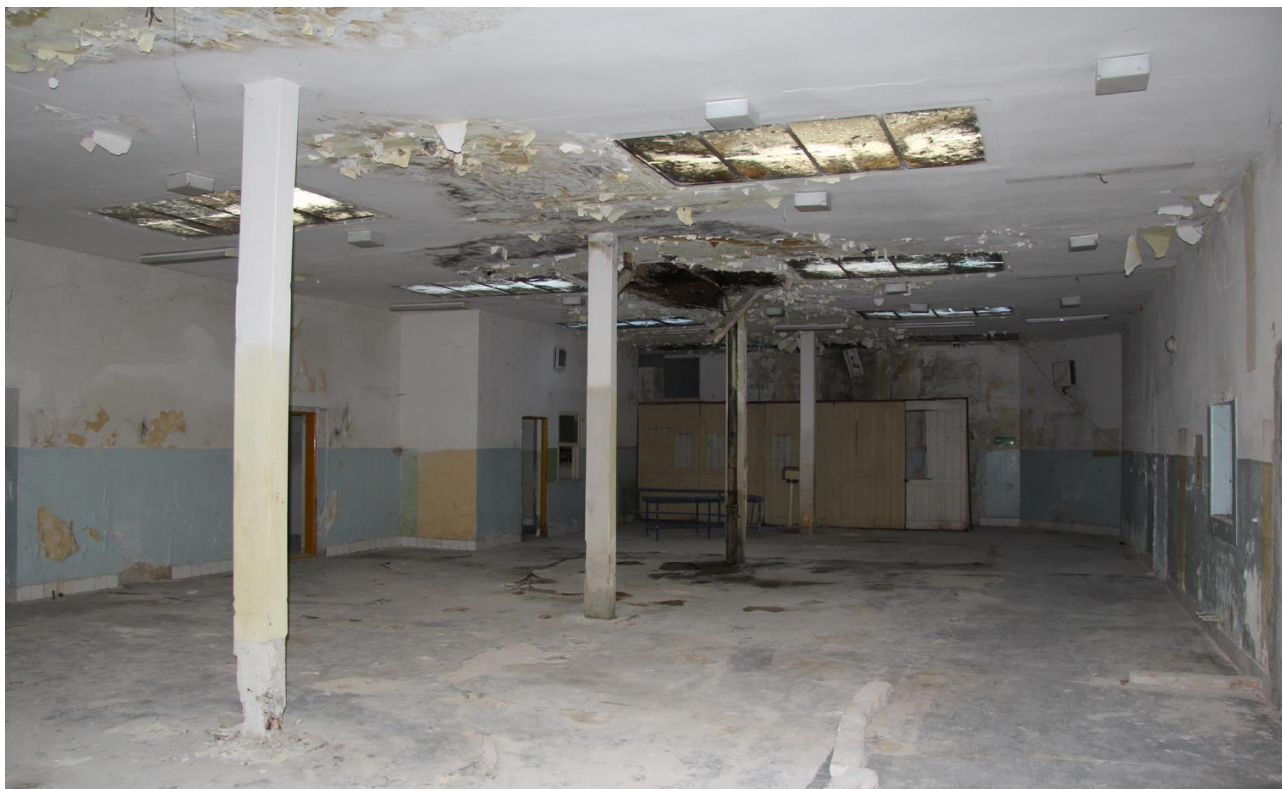
Fig.: 13 Large room in part K – ceiling in a state of serious disrepair
