# **WINTER HARBOUR PROJECT**

## **SURVEYS AND ANALYSES**

**for selected environmental components, analysis  
of abiotic components, negative elements and  
phenomena in the area**

**FEBRUARY 2025**

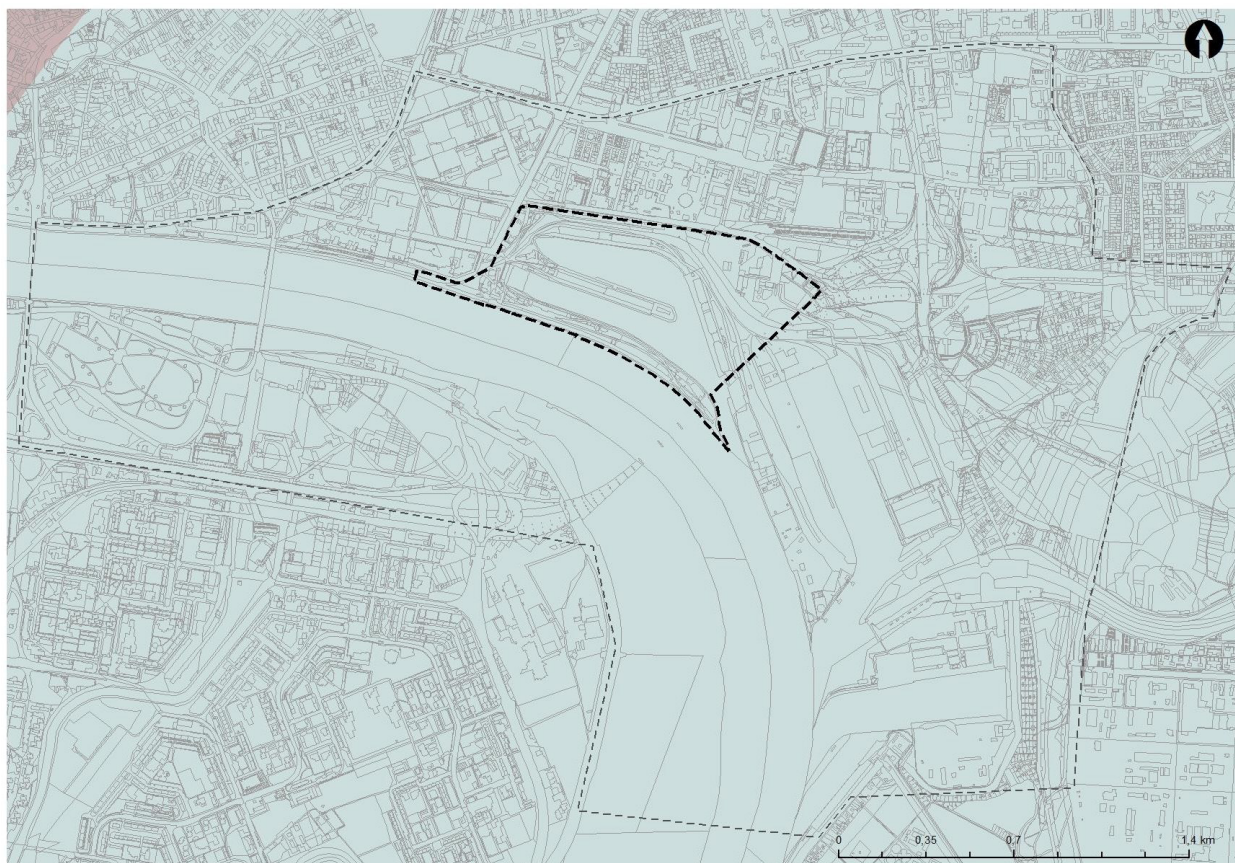
**Figure 1: Geomorphological division of the territory**

The following figure, 'Geomorphological Division of Slovakia', illustrates the area's classification within the geomorphological units of Slovakia.

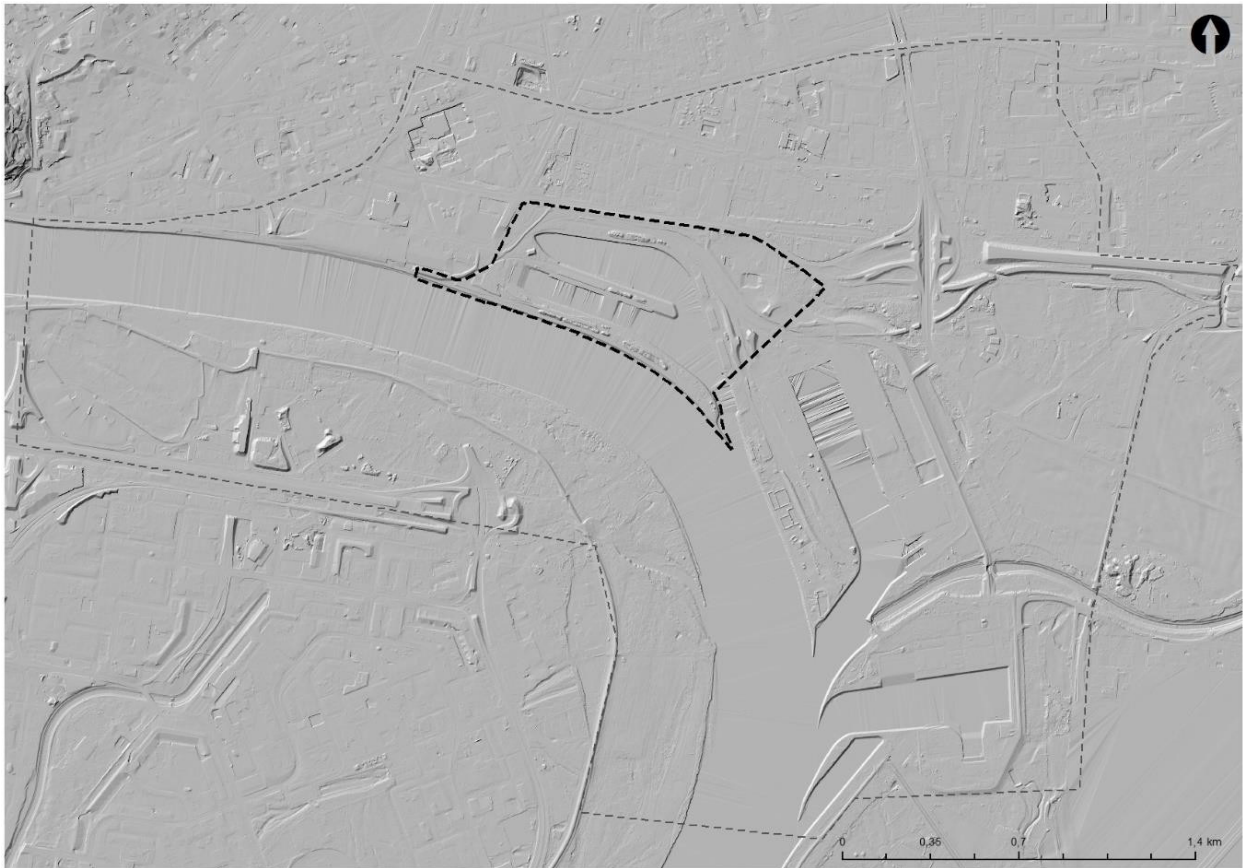
**Figure 3: Digital Elevation Model**

The relief ruggedness of the study area is illustrated in Figure: Digital Elevation Model.

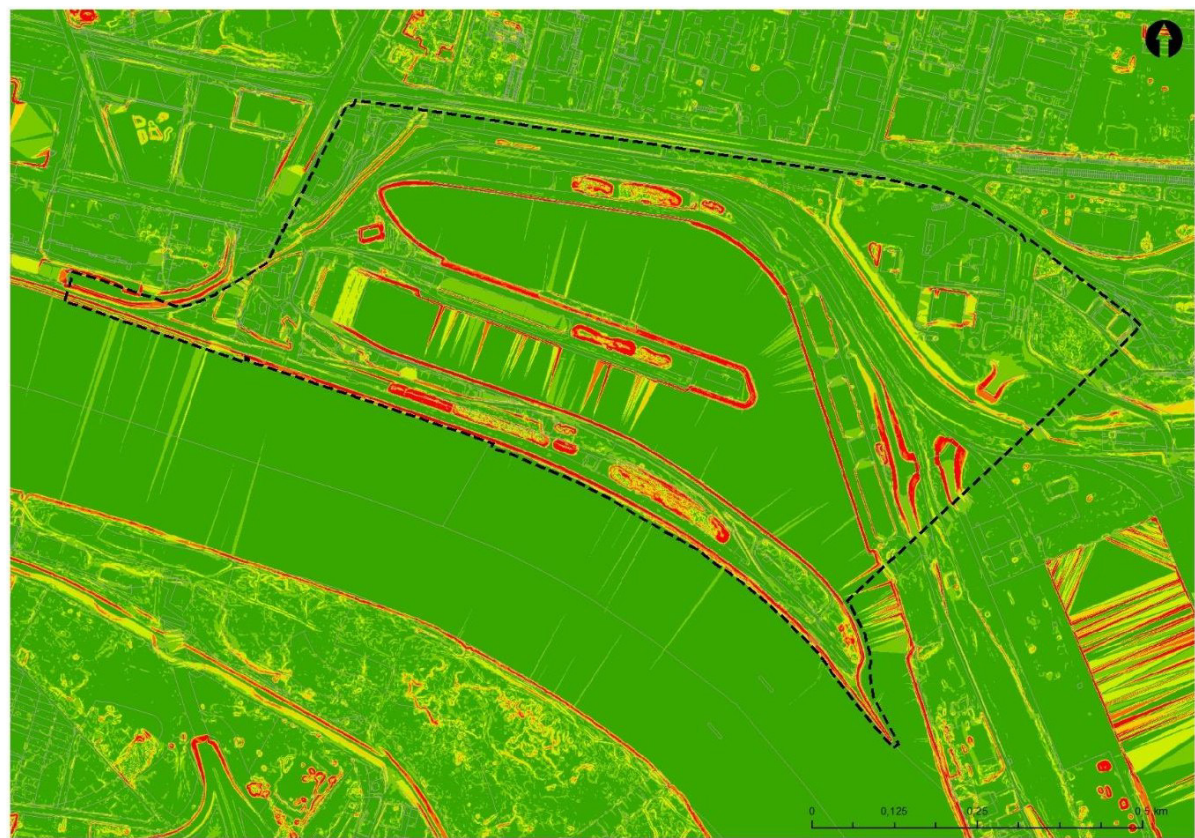
Figure 4: Slope gradient of the area

The distribution of individual slope gradient categories in the area of interest is illustrated in Figure: Slope gradient of the area. The majority of the area lies within a gradient range of  $0^{\circ}$  to  $3^{\circ}$ .
