1. ETAPA

| Akcia : KLASICISTICKA KÚRIA, Rekonštrukcia p.č. 156/1, 156/2 a 156/3 v k.ú. Sobotište | | | | <div>Dátum :</div> <div>April 2021</div> |
| Stavebná časť | | | | <div>Číslo výkresu :</div> <div>ZT-6</div> |
| Pozdĺžny profil dažďovej kanalizácie | | | | |

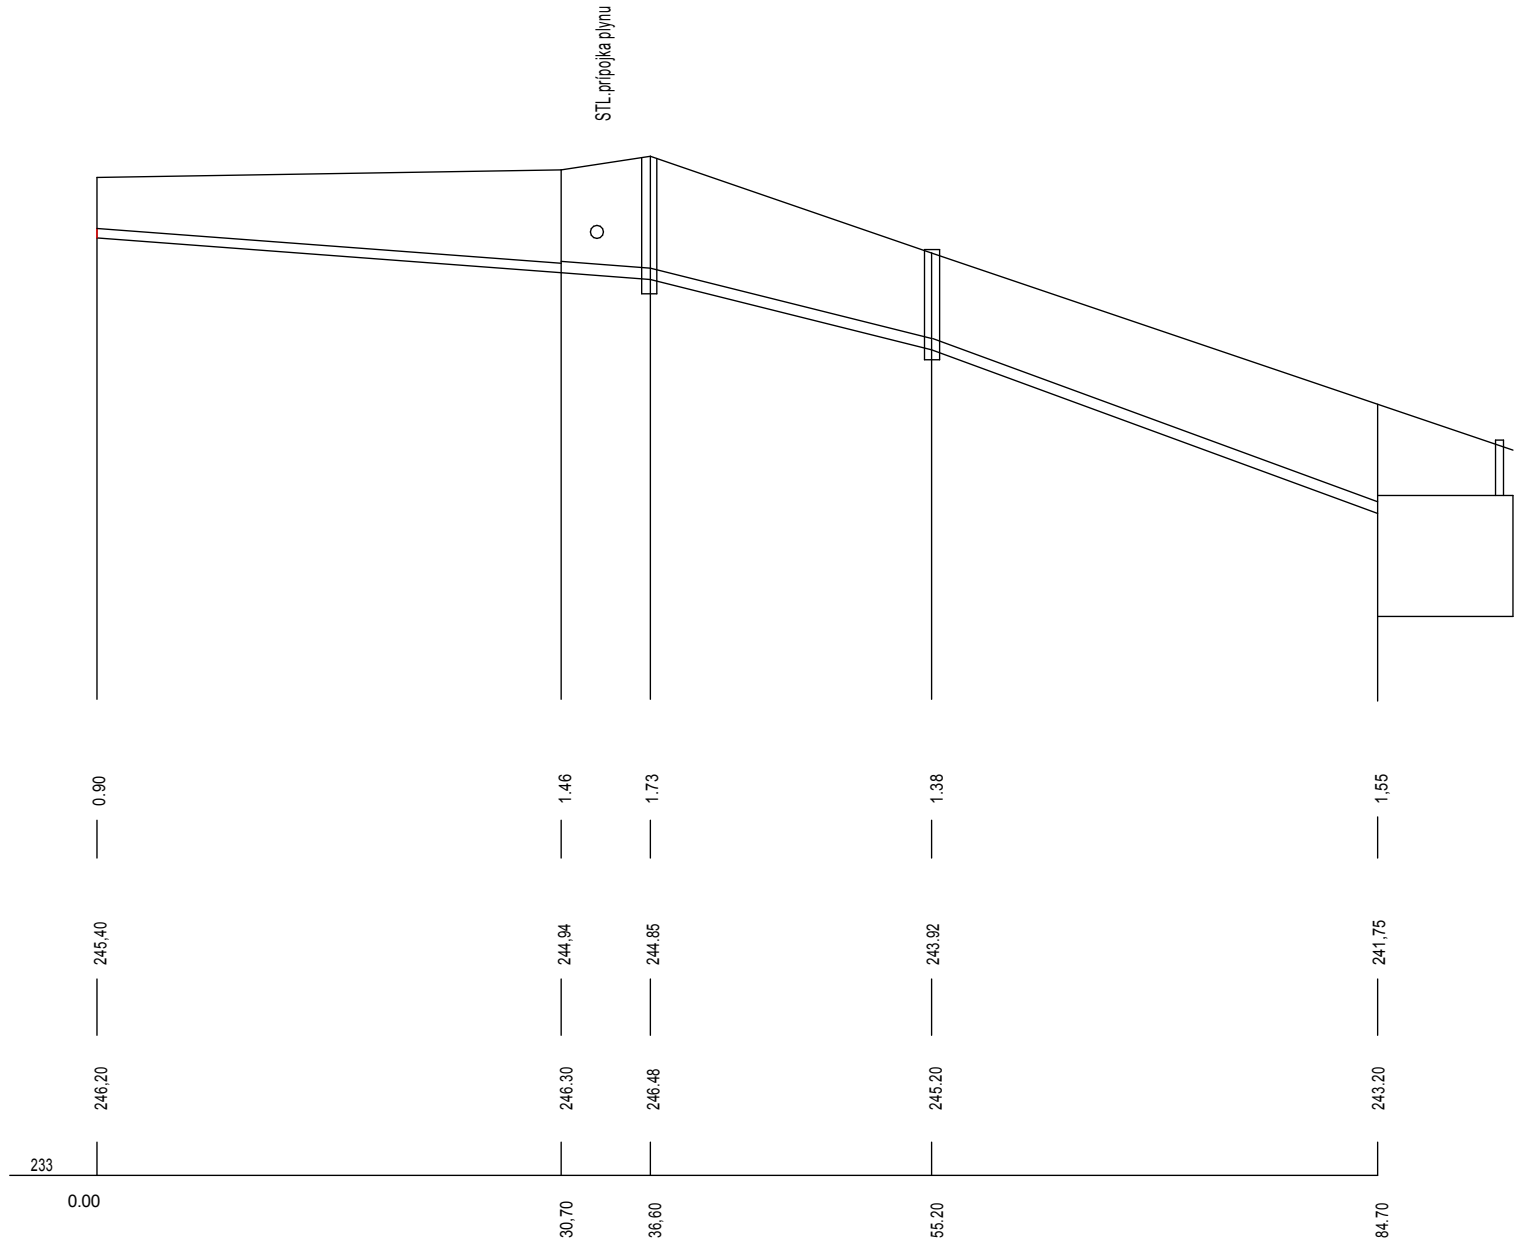
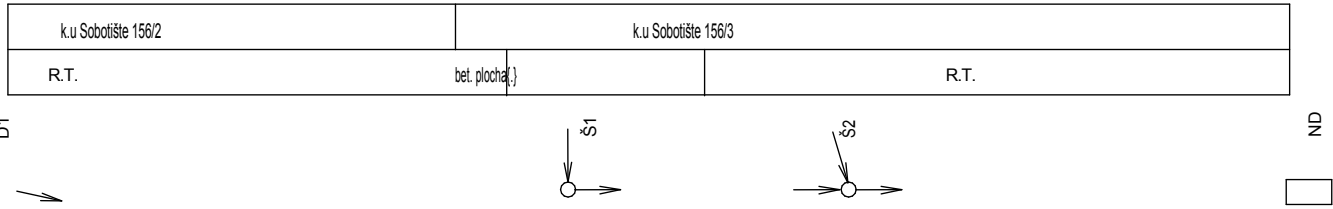
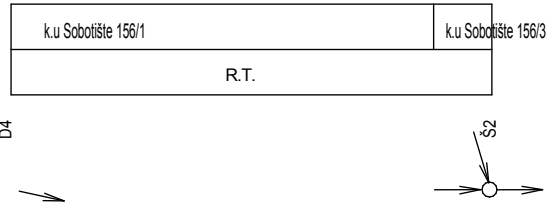
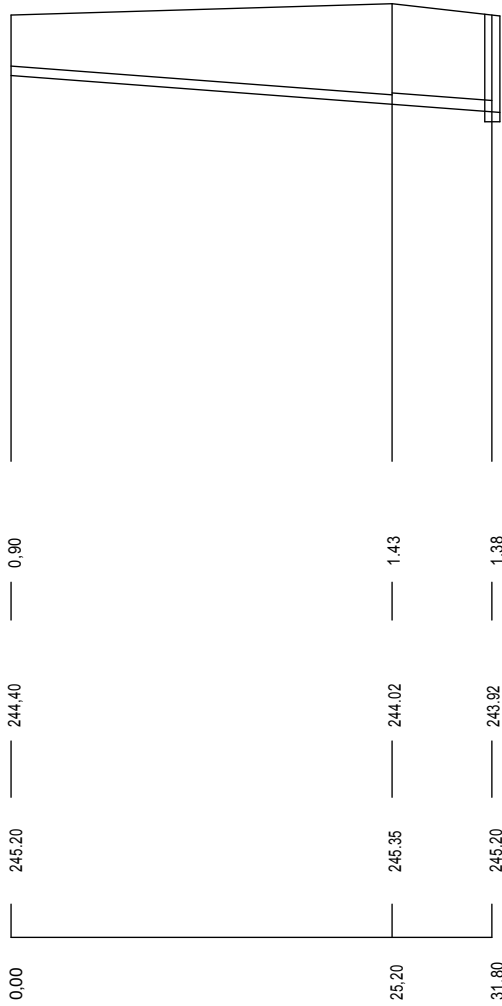
Dažďová kanalizácia

| PVC 125 | | 30,7 | PVC 150 | | | | 54,0 |
| 1,5 | | 36,6 | 5 | 18,6 | 7,3 | | 29,5 |
| 15,2 | 1,30 | 28,4 | 1,55 | 53,4 | 2,9 | 64,2 | 3,45 |

| PVC 125 | 25,2 | PVC 150 | 6,6 |
| 1,5 | 31,8 | | |
| 15,2 | 1,3 | 28,4 | 1,55 |
